PIPING AS A PROCESS OF GULLY EROSION IN SMALL-FORMAT AERIAL PHOTOGRAPHY. A SHORT NOTE

I. MARZOLFF ^{1*} y J. B. RIES ²

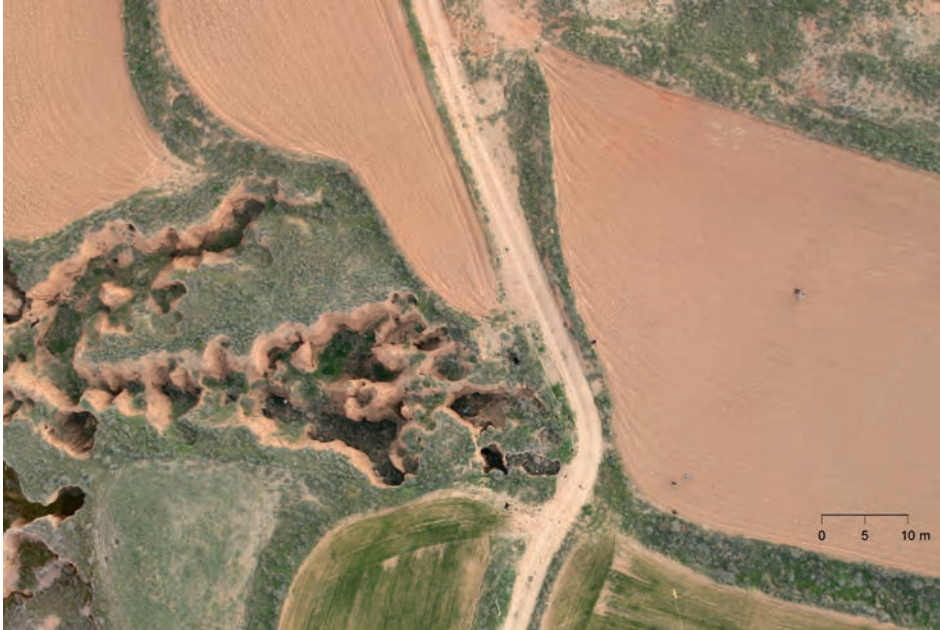
Figure 2. Barranco Rojo, (near Botorrita, Province of Zaragoza, Spain), October 2006.

The aerial photograph of the upslope end of Barranco Rojo (Fig. 2), which cuts into Quaternary alluvial fills deposited in the Huerva catchment, reveals the evolution of the gully from a series of interconnected piping holes that have grown together by collapsing “interfluves”. Stereo-photo analysis of the internal watersheds has shown that the gully part covered by the image is partitioned into 32 separate, subterraneously draining parts. Between 2002 and 2009, the gully has grown exclusively by enlargement of the topmost piping holes adjacent to the dirt track (15.6 m², corresponding to at least 15.4 m³; Marzloff *et al.*, 2011). The pipes act as runoff collectors for the surface water which runs along the terrace bench next to the cereal field in the lower right – one of the main drainage lines of the upslope catchment area (Marzloff and Ries, 2007; Seeger *et al.*, 2009). The occurrence and amount of piping involved in this gully’s development may well be related to the land-levelling activities undertaken for the creation of the surrounding agricultural terraces: Piping holes and breaches of terrace banks can be observed at many places in the immediate vicinity.

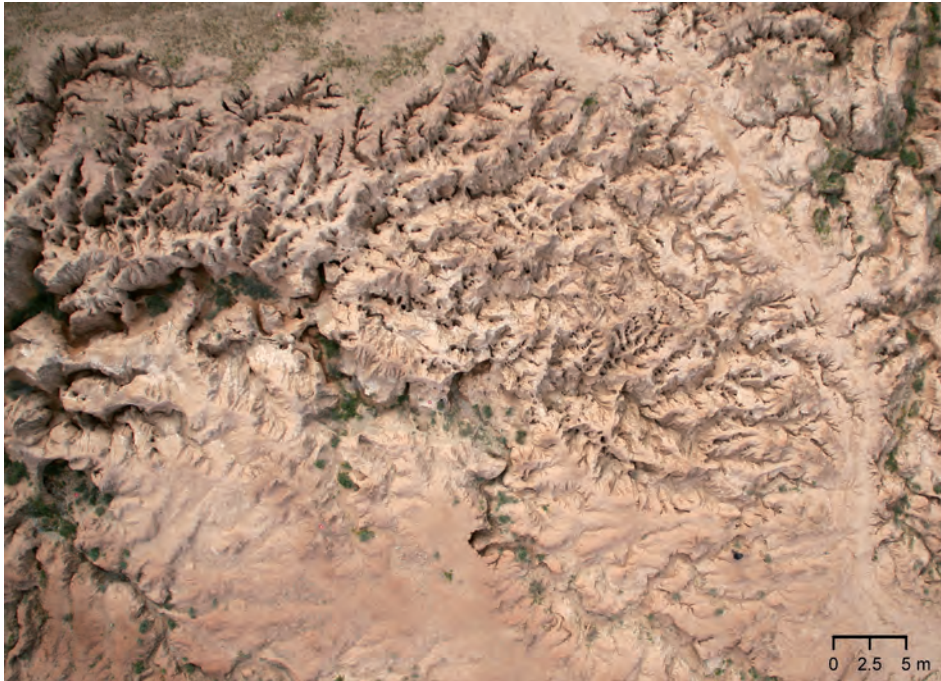
Gully Talaâ (Fig. 3) is situated in an abandoned field near Taroudant, where the large sediment fans of the High Atlas have been dissected into extensive badlands for the last two hundred years. Dense networks of large and deep rills that have reached upslope as far as the watershed leave only a small path on the divide to the next gully system. Only few of the rills appear as clearly linear features in the airphoto: nearly all are fragmented into short sections interconnected by pipes. 644 such piping holes

Figure 3. Gully Talaâ (Souss Basin, Morocco), March 2006.

(5800 pipes/ha) and subterranean rill connections were mapped in the gully part covered by this image, locally reaching a density of up to 1.6 pipes/m². As one of the main Moroccan regions for vegetables, citrus fruit and banana plantations, the Souss Basin is an area under high land-use pressure, and many erosion-affected abandoned fields and badlands are now being levelled with bulldozers to enlarge the area for agro-industrial cultivation. The gully system, which is already visible on satellite images from 1968, might have been infilled and levelled some time before 2005. The reason for the extraordinary density of piping holes tracing subterranean drainage lines might be the pre-existence of an older, buried drainage network that is now being uncovered by revived erosion processes.
