FLOOD HAZARD ASSESSMENT FOR BRIDGE CROSSINGS OVER EPHEMERAL CHANNELS: A CASE STUDY OF THE MURCIA COAST (SE SPAIN)

C. CONESA-GARCÍA¹*, R. GARCÍA-LORENZO²

Key words: floods, bridge crossings, ephemeral channels, hazard index, South East Spain.

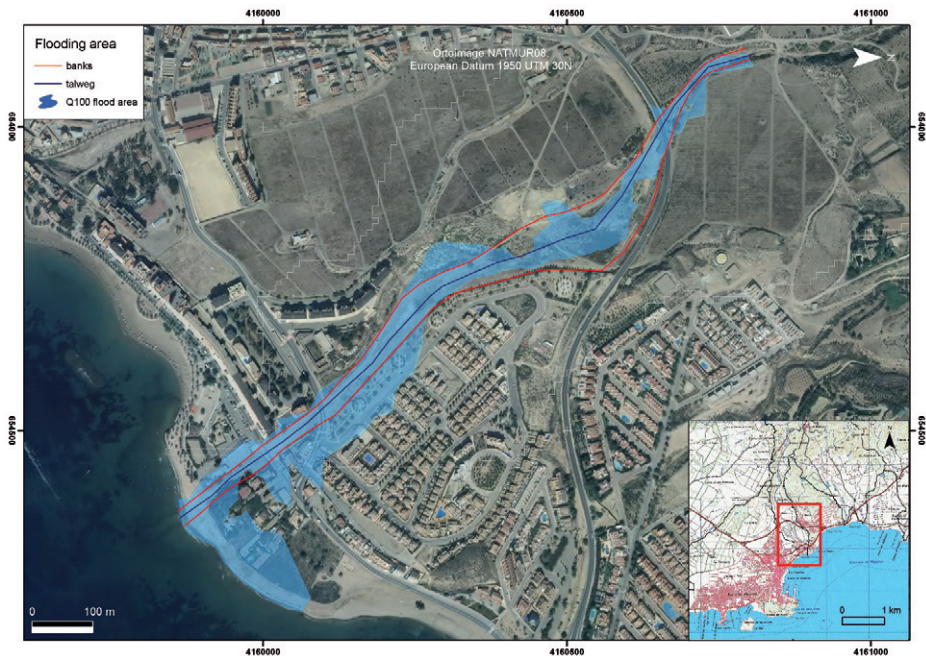
Figure 2. Flooding area obtained using HEC-GeoRAS for a 100-year flood in the Lorentes Rambla.

Two flood hazard indices for bridge crossings were proposed: a *Flood Hazard Index for bridge crossings* (FHI_{BC}), and a *Geomorphological Hazard Index* (GHI_{BC}). FHI_{BC} combined an exposure factor with an inefficiency index of drainage works for different return periods. To obtain hydrological and hydraulic data, HEC GeoRAS was used in a GIS environment (Fig. 2). In particular, its 4.0 version provided details about stable and unstable flow, sub-critical and supercritical flows, and calculations of mixed regimen profiles, already tested on ephemeral drainage networks (García Lorenzo and Conesa García, 2011). The flow profiles were obtained using the standard procedure: the transmission of flooding was processed increasingly for each coordinate and roughness change. The software included applications for hydraulics in bridges, the analysis of confluences and drainage networks, and the interpolation of channel cross-sections.

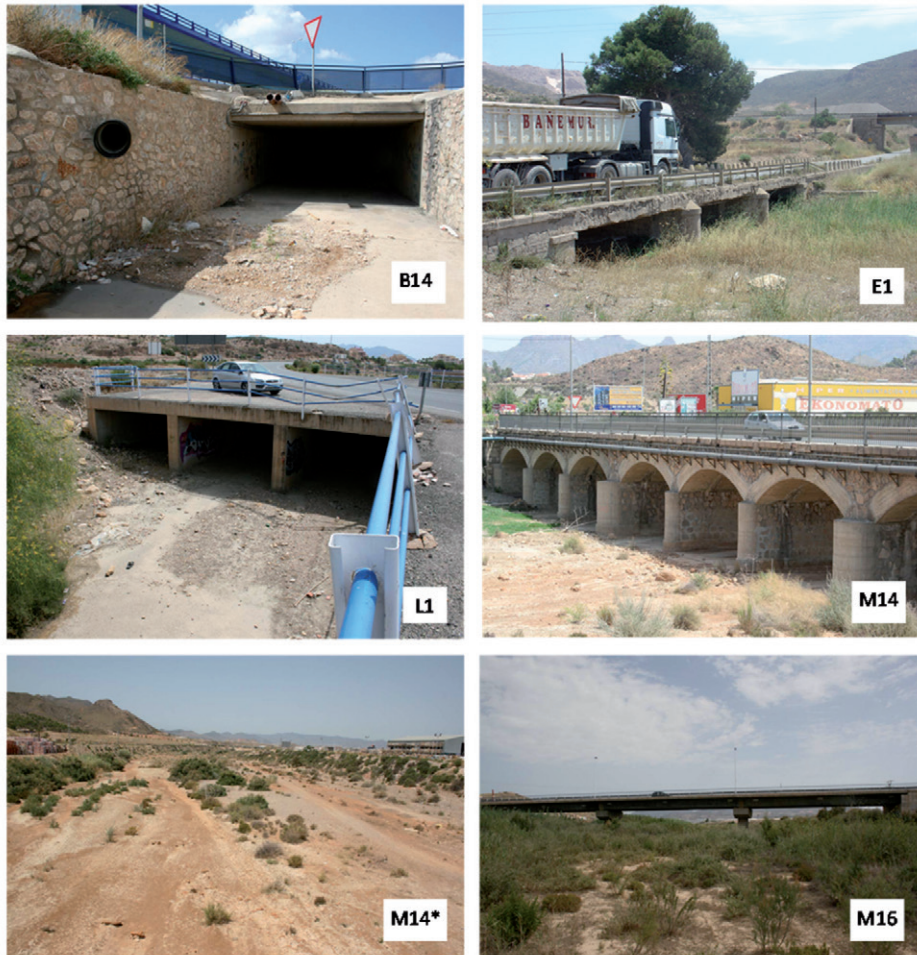
Figure 3. Pontoon in point B14: road crossing the connecting channel between the Dolores *Rambla* and the Benipila *Rambla*. Point E1: the Escombreras *Rambla* intersecting with Mu-320 (local tertiary road). Point L1: crossing of N-332-1 road over the Lorentes *Rambla* saved by pontoons. Point M14: road N-332-1 over the Moreras *Rambla* next to Mazarrón (lower reach). Point M14*: sandy loam bed upstream from the M14 bridge over the Moreras *Rambla*. Point M16: the intersection of the Moreras *Rambla* with D-6 (local tertiary road) which links Mazarrón Port with Bolnuevo (Águilas).

Only three structures, in crossings R9, B14 and E1, are unable to evacuate the water of 100-year floods. R9 is the D-21 road crossing the Planas Gully (a tributary of the Ramonete *Rambla*). At point B14, a regional road crosses the canal link between

the Dolores *Rambla* and the Benipila *Rambla* in the west sector of Cartagena (Fig. 3). In both cases, the drainage structures are pontoons with one or several boxes made of reinforced concrete.

Point E1 corresponds to the MU-320 road crossing the Escombreras *Rambla* over a little bridge with the structure of formwork in bad conditions (Fig. 3). The drainage is carried out through three arches with a height of 1.5 metres and a width of 9 m which together give a maximum combined capacity of $71 \text{ m}^3 \text{ s}^{-1}$ (Table 4).

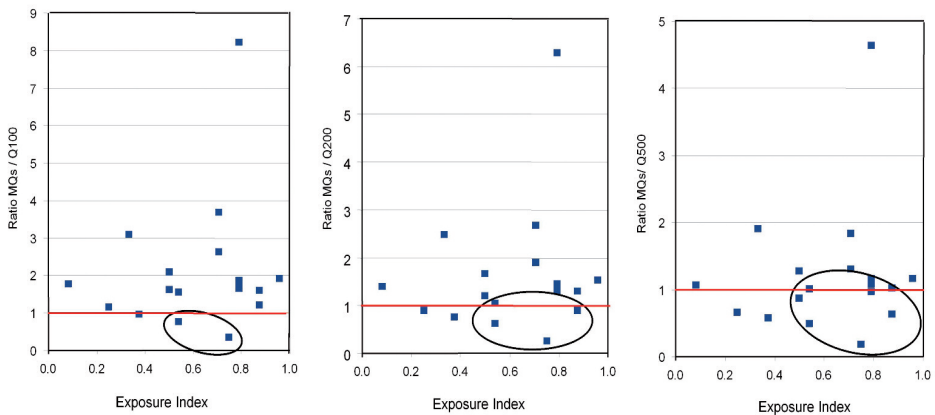
Figure 4. Ratio between bridge flow capacity and discharges for different return periods (MQs/Qx) versus exposure index (I_{EXP}). The dots inscribed in circles represent the most problematic bridges, with an insufficient drainage capacity and a high exposure index.

Fig. 4 shows the ratios between drainage capacity of the bridge spans and estimated discharges for different return periods versus the exposure index values. Just two bridges have high levels of exposure and insufficient capacity for draining 100-year floods. However, four crossings show high flood hazard for ratios $MQs/Q_{200} < 1$ and seven for ratios $MQs/Q_{500} < 1$.

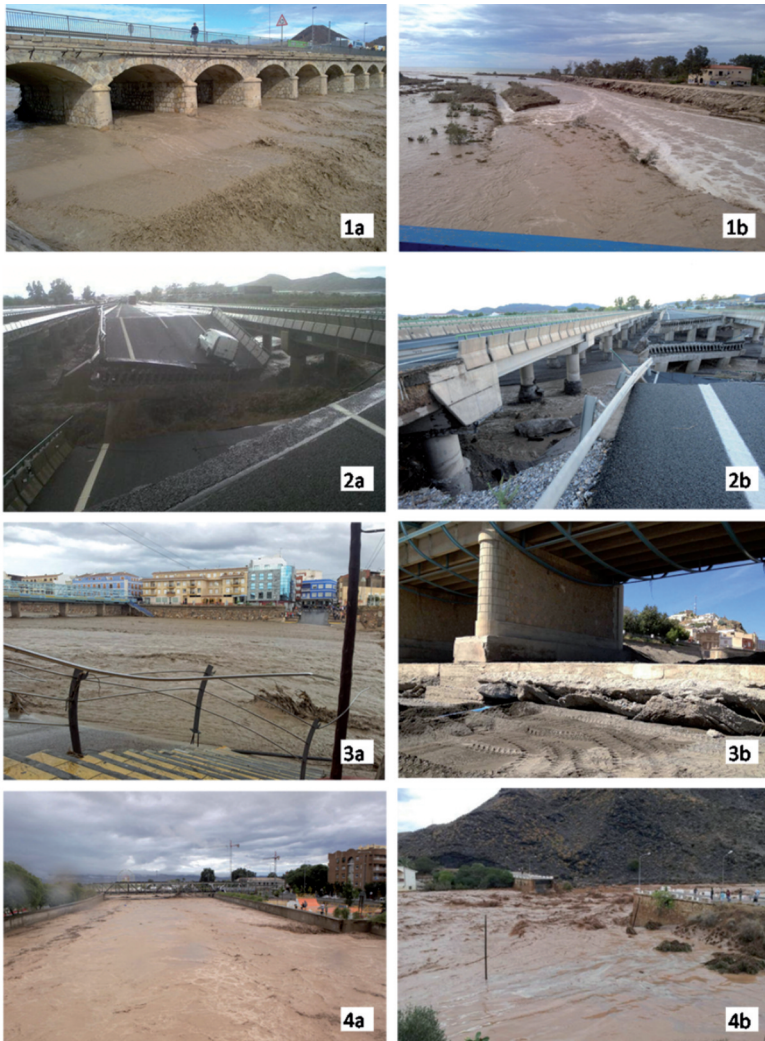
Figure 5. Flooding by ephemeral channels on September 28th, 2012, affecting bridge crossings in South East Spain. Scour holes downstream of crossings M14 (1a) and M16 (1b); Failure of the bridge due to scour at their foundations on the A-7 over the Béjar *Rambla* (2a and 2b); Nogalte *Rambla* at the point where it passes through Puerto Lumbreras before (3a) and after the flood (3b); Guadalentín *Rambla* at its pass through Lorca (4a); Old bridge destroyed by flooding in Lobos *Rambla* (4b).

Some field evidence of overflow and morphological effects from recent extreme floods (Conesa-García *et al.*, 2010) corroborates these findings. The destructive effects of the floods on 23rd October 2000 and 28th September 2012 are two clear examples (Fig. 5). On both dates, several vital bridges and large stretches of roads were washed away in flash floods caused by heavy rains in Southeast Spain. Huge storms, with precipitation higher than 120 mm in a few hours reached large headwaters causing *ramblas* to overflow. Over five bridges in areas of Murcia and Almería failed due to the scour of foundation material. In particular, two important bridges were destroyed on the AP-7 and A-7 Mediterranean highways. The bridge of the A-7 over the Béjar *Rambla* (Fig. 5: 2a) was located downstream an aggregate load and it led to a slow lowering of

the bed and progressive channel degradation. Over recent decades this ephemeral stream has become deficient in sediment supply due to sediment being removed upstream, so bed scouring around bridge abutments or piers has increased. Finally, new scour holes of up to more than two meters of depth were scooped out during the flood of 28th October 2012, endangering the integrity of the structure. Foundations of piers were totally exposed and the bridge failed (Fig. 5: 2b). On the same date the foundation of the Puerto-Lumbreras bridge was also dug up by flooding of the Nogalte *Rambla*, which reached a peak discharge of higher than 700 m³ and a GTS of about 1.4 m (Fig. 5: 3b).

At bridge openings, contraction scour occurred in many cases, especially at cross-sections in which the opening was much narrower than the channel upstream the bridge. Degradation scour took place upstream and downstream bridges over large areas. High channel instability resulting in *rambla* erosion and changing angles-of-attack contributed to bridge scour. Debris also had a substantial impact on bridge scour in several ways. For example, a build-up of material under the bridge of Lobos reduced the size of the waterway causing contraction scour in its channel (Fig. 5: 4b). A high bedload was already being transported into the contracted bridge section from upstream of the approach section. In addition, debris deflected the water flow, changing the angle of attack, and increasing local scour. It resulted in a significant live-bed contraction scour, in which the critical velocity of the bed material ($V_c \approx 1.74 \text{ m s}^{-1}$) was much lower than the mean velocity at the approach section ($V = 6.3 \text{ m s}^{-1}$). The road embankments at the proximity of the bridge caused all the overbank flow to be forced into the main channel; the bridge abutments were projected into the main channel and the bridge piers blocked a significant portion of the flow area. During flooding, although the foundations of certain single-span bridges did not suffer damage, flow around abutments and approach embankments and the associated scour at those locations strongly influenced scour at the piers into the main channel.
