THE FLOOD OF OCTOBER 9, 2018 IN THE CITY CENTRE OF SANT LLORENÇ DES CARDASSAR (MALLORCA)

MIQUEL GRIMALT- GELABERT*, JOAN BAUZÀ-LLINÁS,
MARÍA C. GENOVART-RAPADO

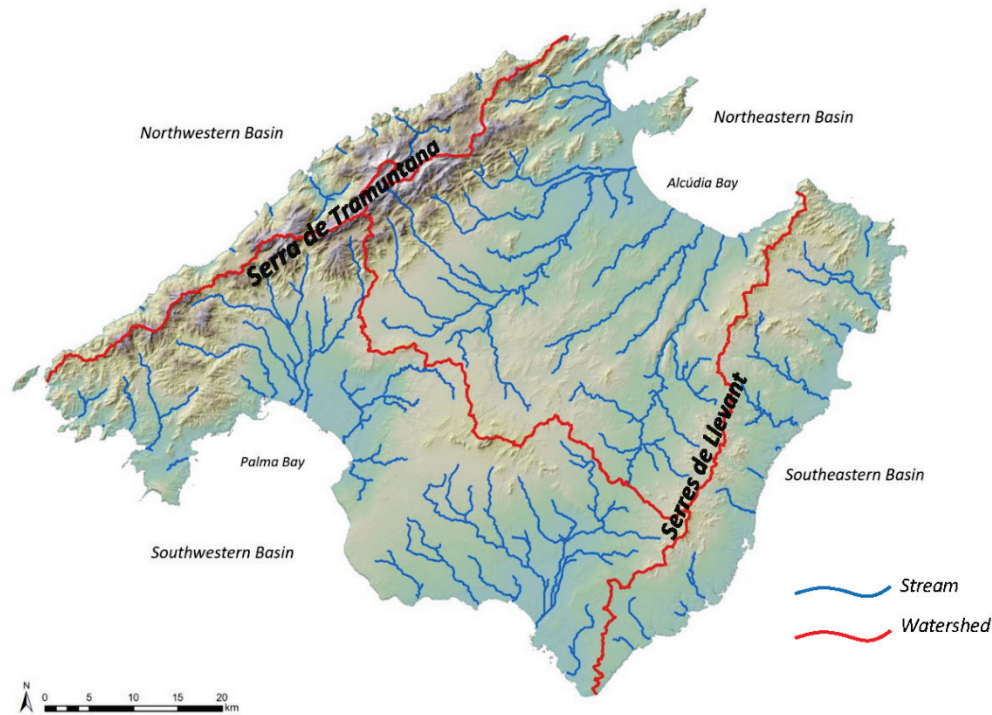
Figure 1. Distribution of the superficial hydrography of Mallorca.

The hydrographic network of Mallorca (Fig. 1) consists of a group of sporadic water flows (referred to as *torrent* and *xaragall*). There are no permanent rivers, except for reduced sections that are permanently fed by agrarian drainage systems.

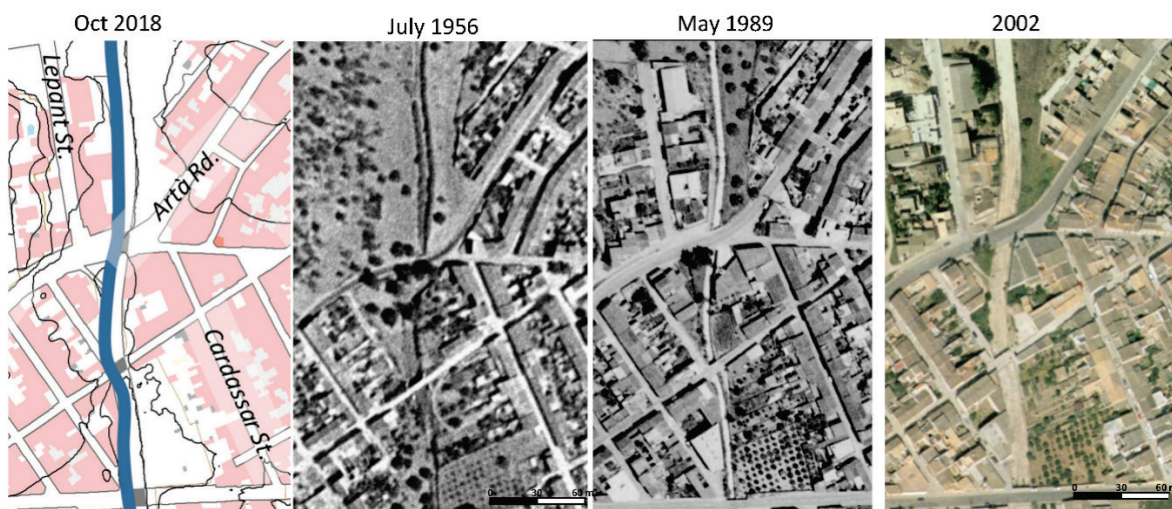
Figure 4. Aerial view of Sant Llorenç, which was already settled in 1956. Between 1970 and 1998, only a few warehouses and buildings were added in the area close to the watercourse, and the streets surrounding Lepant street were built. The watercourse was upgraded from a small canal (1956) to an artificial 4-metres-wide cemented canal in the 70s and 90s. In 1990 it was widened to 12 m, after the flash-flood in 1989.

In the second half of the 20th century, the layout of the watercourse through the city centre has undergone several modifications, some of them as a response to floods (Fig. 4).

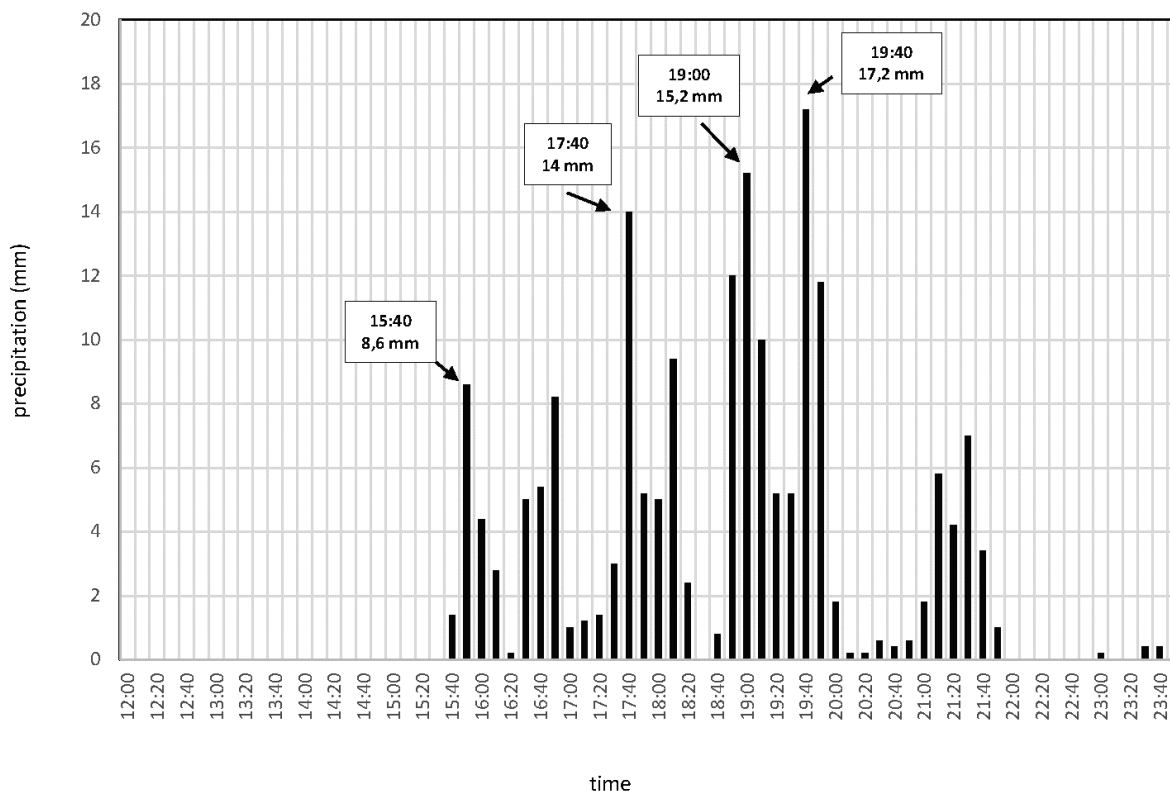
Figure 5. Rain distribution from Son Carrió observatory. The episode initiated at 15:30 h and lasted until 22:00 h. There are several peaks of intensity, being the one between 18:50-19:50 h the most remarkable one, with 76 mm in an hour span. The peak flood happens this same hour.

The time-intensity is more remarkable than the total rainfall, featuring heavy rains that alternated with light drizzling. The chart from *Son Carrió* observatory (Fig. 5), in lapses of 10 minutes, evidences this alternance.

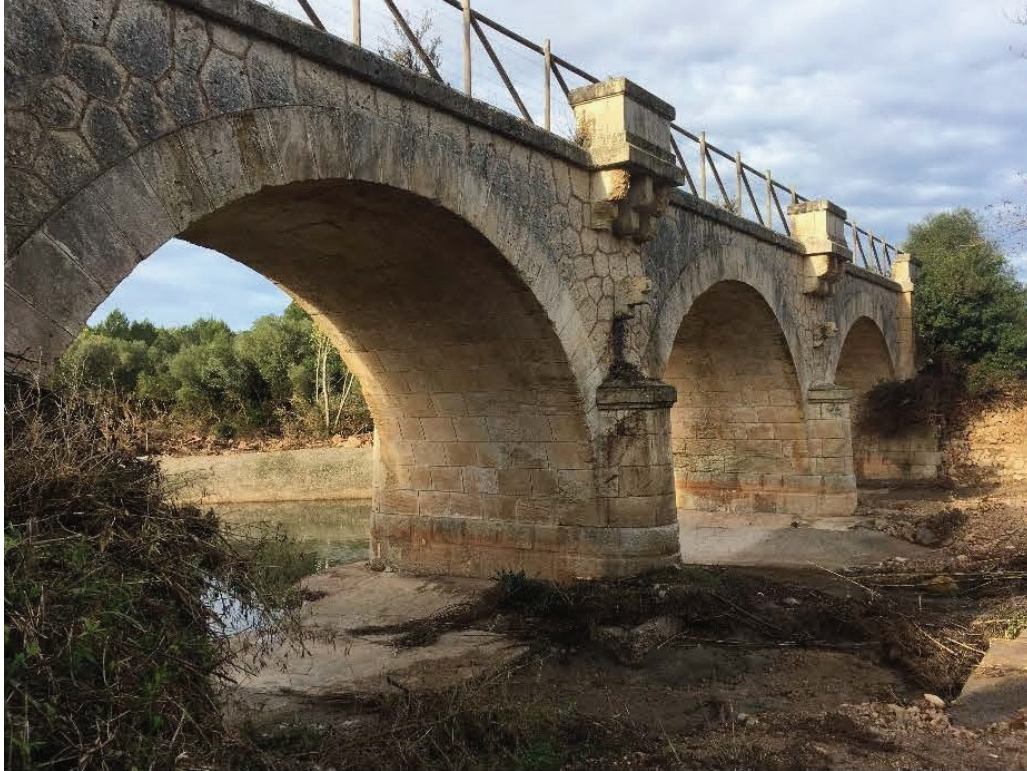
Figure 7. Rail-road bridge over torrent de ca n' Amer, with a total span of 100 m². During the flood in 2018 it worked to its limit, being used as flow control point.

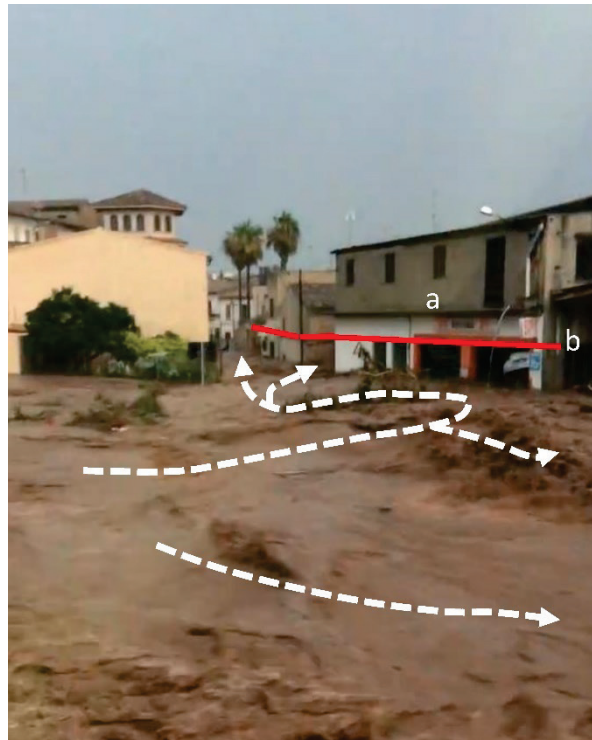
Figure 13. Image of the flood in the bridge Pont de Can Gostí minutes before the peak. The water flow is diverted by the warehouse adjacent to the watercourse (a). The peak of the flood was 2.8 m above the pavement (b).

The behaviour of the flood in the urban area is related to several circumstances that combine the natural features of the terrain with the urban layout and some other isolated factors which hindered the watercourse (Fig. 13).
