## SPATIAL VARIABILITY OF CHANNEL CHANGES IN A MEDITERRANEAN EPHEMERAL STREAM IN THE LAST SIX DECADES (1946-2006)

C. SANCHIS-IBOR<sup>1</sup>, F. SEGURA-BELTRÁN<sup>2\*</sup>

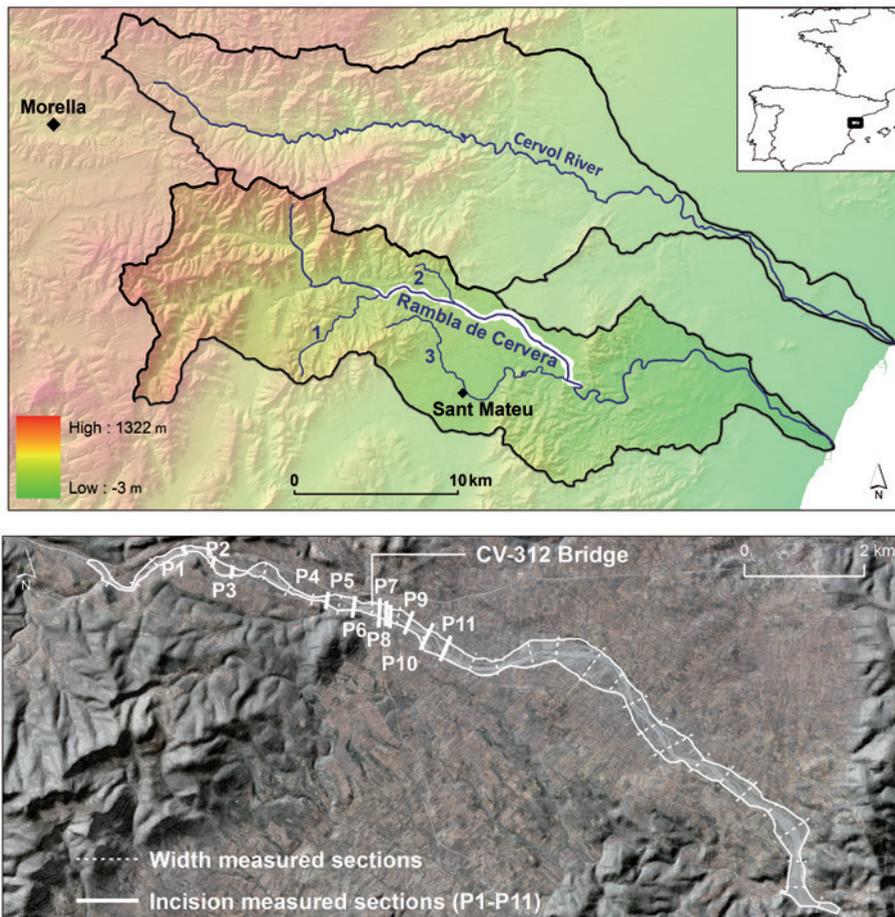
Figure 1. Sketch of location: (Upper panel, A) Rambla de Cervera and Cervol River basins and weather stations, with the study reach in white. 1. Barranc del Molinar, 2. Barranc de la Font and 3. Barranc de Mateu Sant; (Lower panel, B) Rambla de Cervera study reach and sections where incision and width were measured. The channel width (the sum of the single branches widths) has been measured every 500 m. Eleven sections were selected in order to measure incision processes. The hillshade map shows the contrast between the horst and the graben area.

Between 1946 and 2006 the Rambla de Cervera, an ephemeral stream in the north of Valencia Region (Spain) (Fig. 1), underwent channel adjustments comparable to those observed in other Mediterranean rivers. The gravel channel markedly narrowed, losing width (68.5%) and channel surface area (45.7%), and incision processes occurred along the entire study reach at an average depth of 3.5 m. These morphological changes exhibit an interesting temporal variability, with a maximum decrease of the gravel channel in the period 1946-1956 and another clear narrowing stage between 1977 and 1991, whereas

The basin of the Rambla de Cervera (339.6 km<sup>2</sup>) is located in the Oriental Sector of the Iberian Mountain Range (Fig. 1A). The mountain range was folded during the paroxysmal compressive phase in the Oligocene, when anticlinal and synclinal

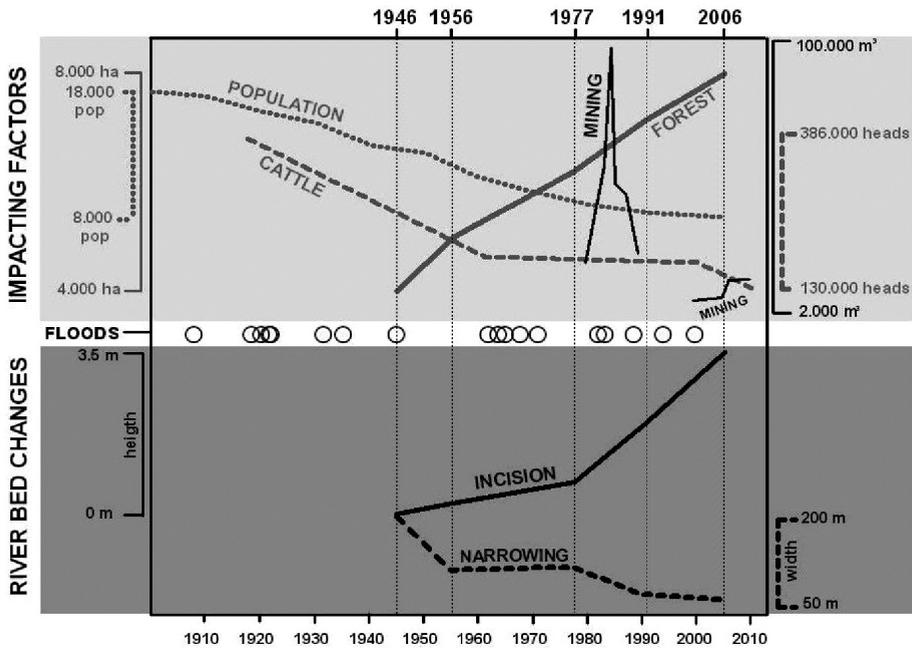
Figure 2. Trends of river adjustments, main human disturbance factors, and natural reforestation causing bed river changes in the Rambla de Cervera (Segura-Beltrán and Sanchis-Ibor, 2013).

Comparing the progress of incision in the study reach with the river mean width, we observe a marked divergence (Fig. 2). On the one hand, incision slowly progressed during the two first stages and increased markedly after 1977; on the other, the channel width decreased significantly in the initial period and, after a stage of readjustment 1956-1977, continued decreasing moderately until 2006. This different behavior is probably reflecting the impact of gravel mining in the incision processes.

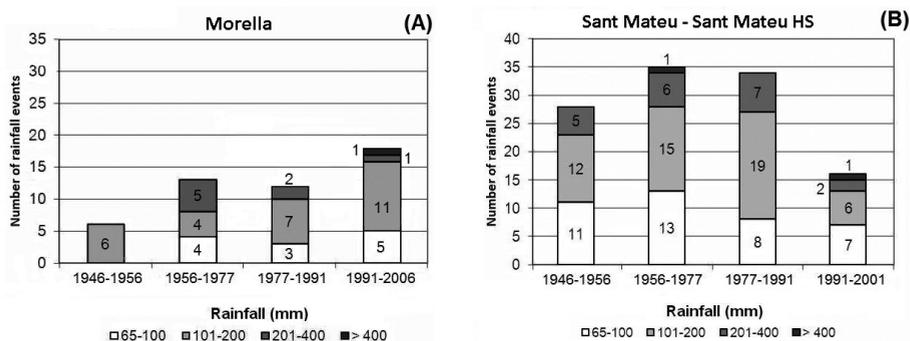
Figure 3. Number of rainfall events > 65 mm recorded in each of the study periods in Morella (A) and Sant Mateu (B).

Rainfall data analysis shows a different behavior between the headwaters (Morella and Morella la Vella) and the study reach (Sant Mateu and Sant Mateu HS) weather stations. From the comparison we have made between the climatic series, we observe that the number of events that exceed the runoff threshold (>65 mm) is considerably higher in the study reach sector, doubling and tripling the headwaters figures; events >200 mm are also more frequent in the graben (Fig. 3).

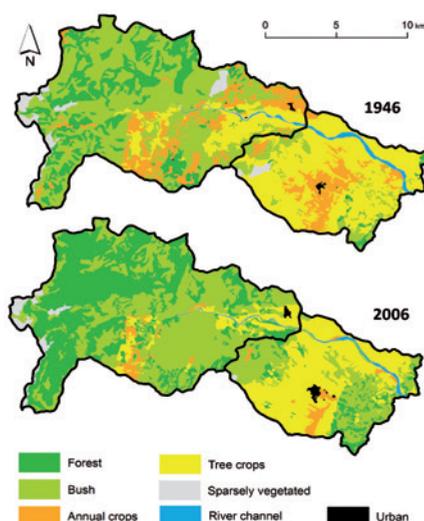
Figure 4. Land use changes in the basin areas affecting the graben and horst sectors.

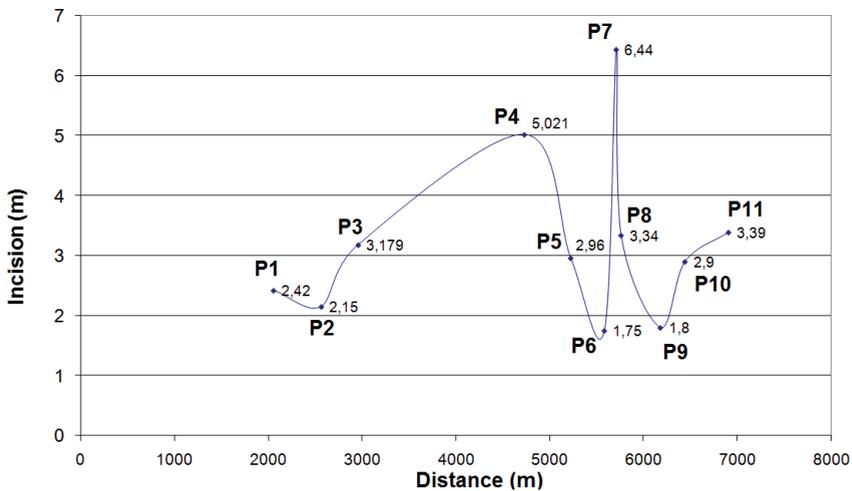
Figure 5. Accumulated incision in the study reach.

The average bed incision of the study reach is 3.5 m, but there is an important spatio-temporal variability. P4 and P7 present the maximum streambed degradation, clearly conditioned by local factors. P4 (distance = 4728 m, incision = 5 m, width section = 57 m) is located in the narrowest section of the study reach (Fig. 1B). At this point, the hydraulic radius is high, enhancing incision during floods. P7 (distance = 5078, incision = 6.44 m, width section = 200 m) is located immediately downstream of the CV-312 250 m long bridge. Here, incision has been mainly caused by local scour, generating an artificial knickpoint. The concrete footing of the bridge acts as a dyke, stopping headwater erosion and hindering slope regularization. In fact, the lowest values are found at P6 (distance = 5582, incision = 1.75 m and width = 215), located upstream of the bridge (Figs. 5 and 6).

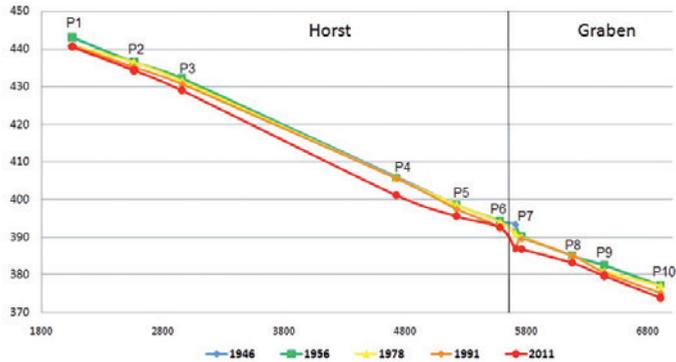
Figure 6. Changes in the longitudinal profile according to the incision estimated in the study area.

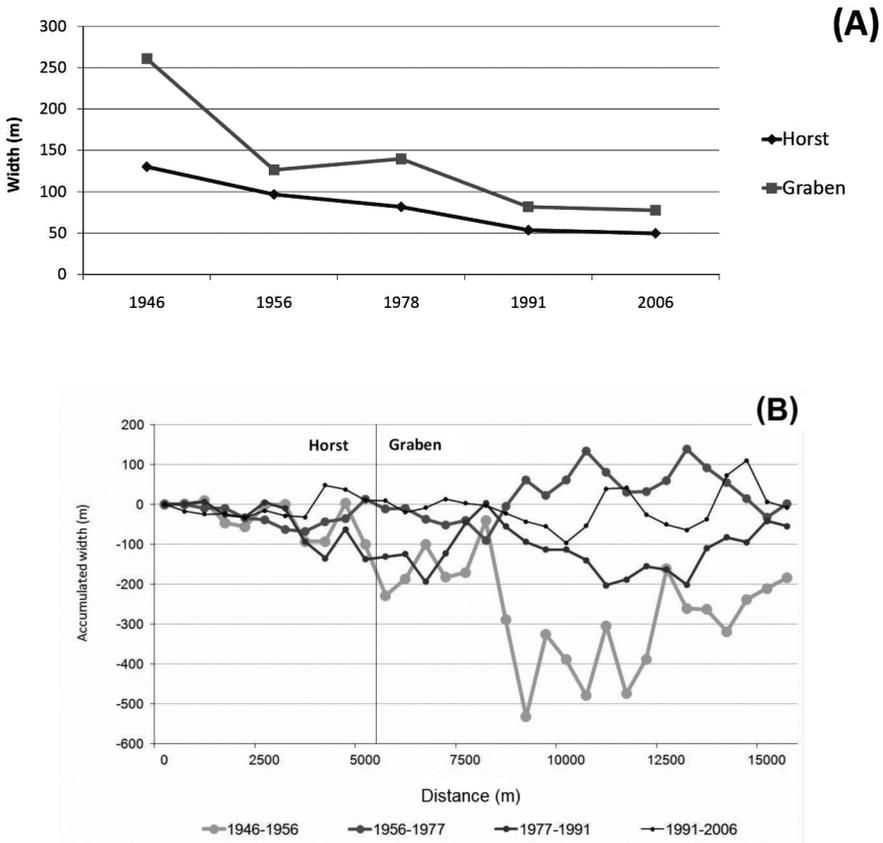
*Figure 7. Changes in channel width: (A) Mean values of channel width in the horst and graben sectors; (B) Spatio-temporal distribution of accumulated width change.*

The channel width reduction has not been uniform. During the period 1946-2006, the mean width reduction was 62.3% in the horst sector and 70.2% in the graben sector (Fig. 7). The major decrease took place in the graben sector between 1946 and 1956, when the channel lost 51.6% width, doubling the horst losses (25.7%). During the period 1956-1977 both sectors followed different trends, increasing width in the graben sector (10%), but decreasing in the horst area (15.5%). Subsequently, both sectors decreased, markedly between 1977 and 1991 (34.4% in the horst and 41.5% in the graben) and smoothly after 1991 (7.3% in the horst and 5.1% in the graben).

The spatial variability of the channel width changes is particularly relevant. Fig. 7B shows a dual behavior between horst and graben sectors. The horst area underwent a slow and almost constant decrease before 1991, reaching stability during the last period. However, the graben followed a more variable trend. The reduction of the periods 1946-1956 and 1977-1999 was balanced during the other two periods, particularly by the gains of the period 1956-1977.

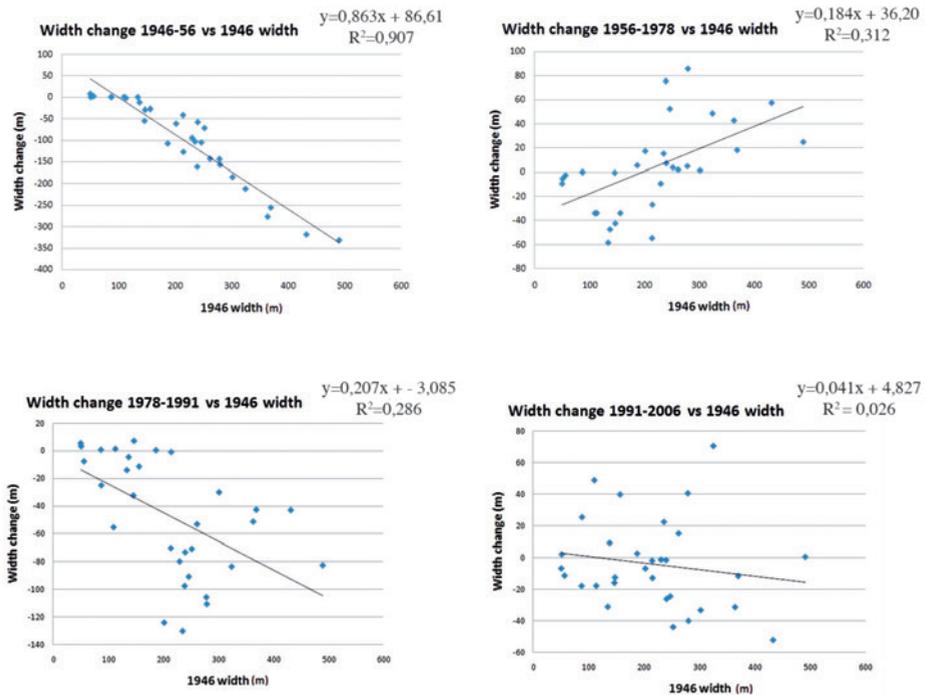
Figure 8. Correlation between the initial channel width (1946) and the change of channel width in each of the study periods.

These data suggest that, when the narrowing process affects the whole river, there is a direct and positive correlation between the initial width and the width reduction. However, when the river undergoes through mixed trends, the correlation is weaker. Thus, the 1956-1978 and 1991-2006 data show that the wider sections grow whereas the narrower are stable or decreasing.

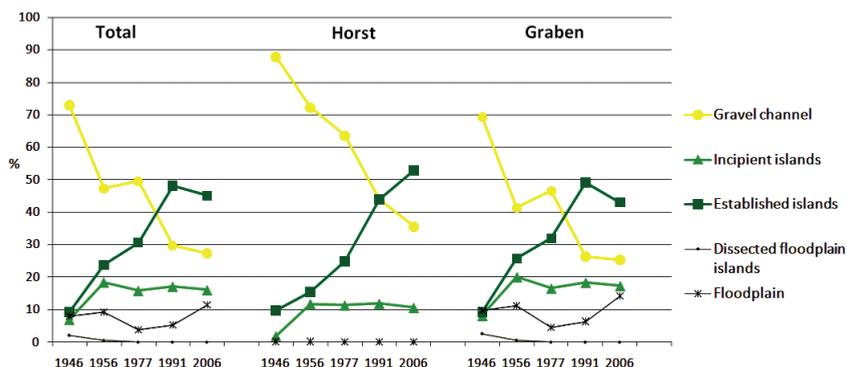
Figure 9. Compared evolution of channel forms in the horst and graben sections.

i) 1946-1956. The gravel channel underwent the major loss (97 ha). In this period, the gravel channel was occupied by incipient and established islands, whereas the floodplain surface slightly increased (Fig. 9).

During the study period, the scope of these morphological changes differs in the two sections of the study area (Fig. 9):

- During the whole study period, changes are more sustained and gradual in the horst area, whereas in the graben sector important oscillations take place.
- Graben changes condition the evolution of the total study reach, because of the larger size of this sector. Thus, important changes in the graben forms, such as the drastic reduction of the gravel channel in the period 1946-1956 or the subsequent recovery (1956-1977), are also reflected as general trends.
- Incipient islands are less significant in the horst sector, and they present also more stability.
- Floodplain is not relevant in the evolution of the horst sector; it remains almost unaltered through all the periods.

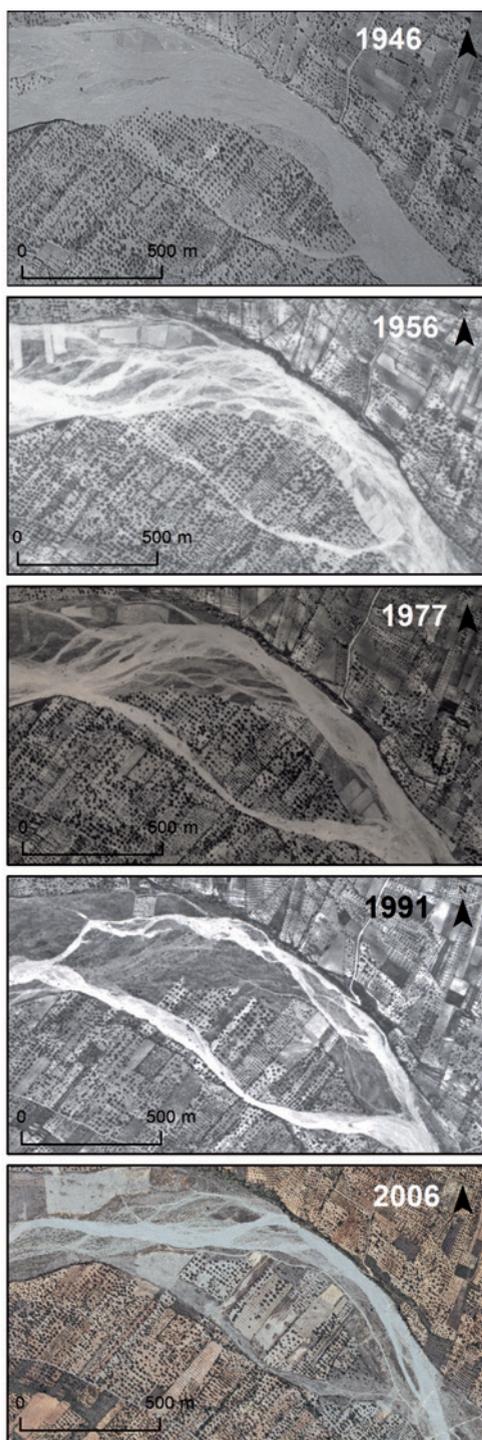
Figure 10. Evolution of a floodplain dissected island in the graben sector. A chute-channel dissected part of the floodplain during the flood of 1945. Subsequent events in the period 1956-1957 consolidated this channel form. Incision processes induced by gravel mining in the main gravel channel left the chute-channel lifted and, after the flood of 2000, it has been inactive. After 2006, part of the old channel has been planted with new olive groves.

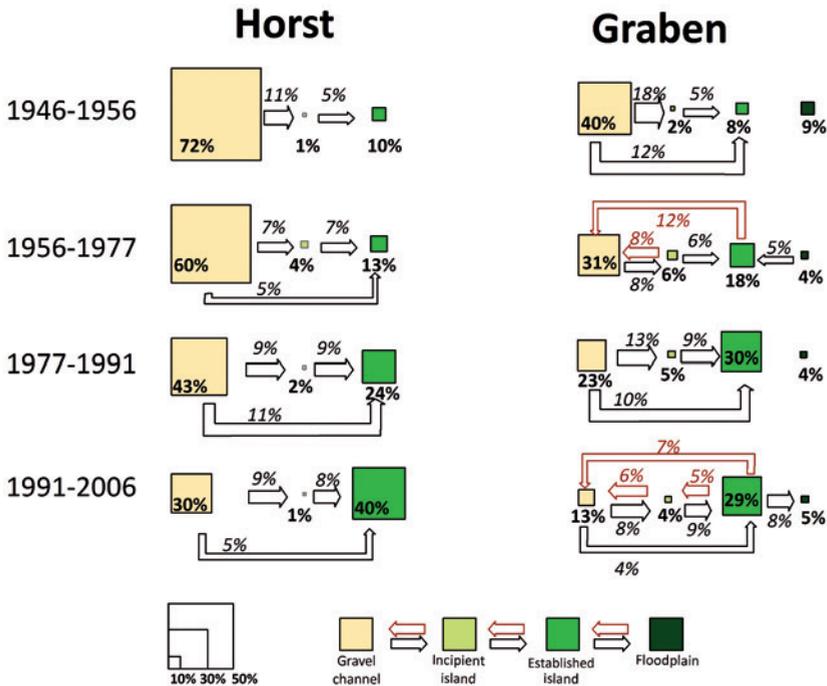
Figure 11. Evolutionary trends of corridor morphological units. The numbers express percentages (>4%) of the surfaces moving from one category to another or remaining stable. Floodplain constructive trajectories (arrows in black) reflect gravel channel evolving to incipient islands and these to established islands, reducing the gravel channel. Regressive trends (in red) reflect floodplain destructive processes.

In general terms, the constructive stages present similar values in both sectors, but the intensity of the morphological changes is always higher in the graben sector, particularly during the first stage (1946-1956). The horst sector is not affected by destructive processes, despite their significant impact on graben forms. The stability of horst forms is also more significant in all the periods, ranging between 83% and 69%, whereas in the graben sector oscillates between 67% and 51%.

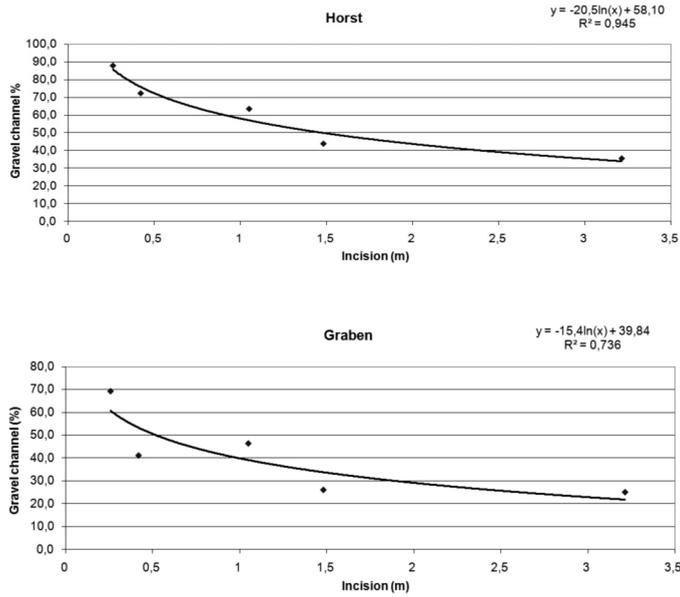
Figure 12. Correlation between gravel channel surface (%) and incision in the horst and graben sectors.

Other two factors must be considered to properly analyze the dual behavior between the graben and horst sectors. First, despite the poor information provided by the administration on gravel mining, photointerpretation shows that this activity was particularly intense in the graben sector. However, the scarce scope of the floodplain destructive processes in the 1977-1991 period, when this activity reached a maximum, proves the limited direct impact of gravel mining in channel planform changes in this study case. The evolution of the study reach proves that gravel mining has had a direct impact on incision processes, but the influence of this activity on the change of channel forms has been indirect, translated through the alteration of the hydraulic radius.

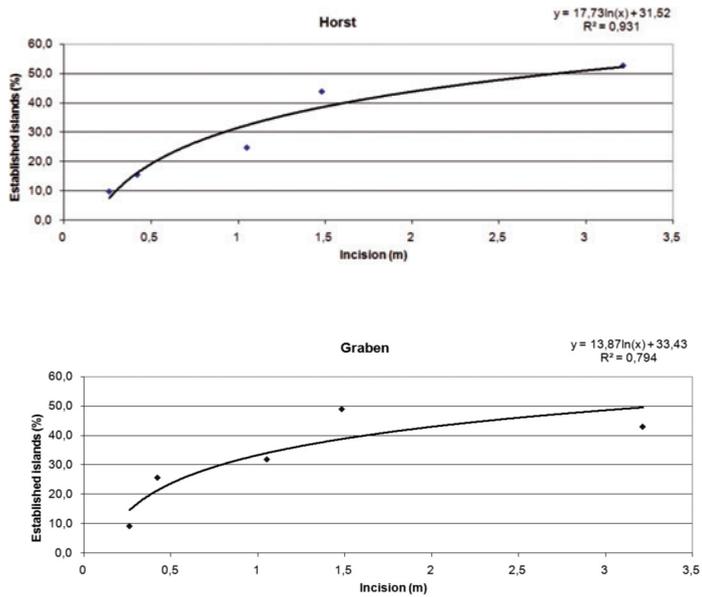
Figure 13. Correlation between consolidated islands surface (%) and incision in the horst and graben sectors.
